CARR - 664

OLD WESTMINSTER ROAD HOUSE

## WESTMINSTER PLANNING DISTRICT

## FIELD SHEET--HISTORIC RESOURCES SURVEY

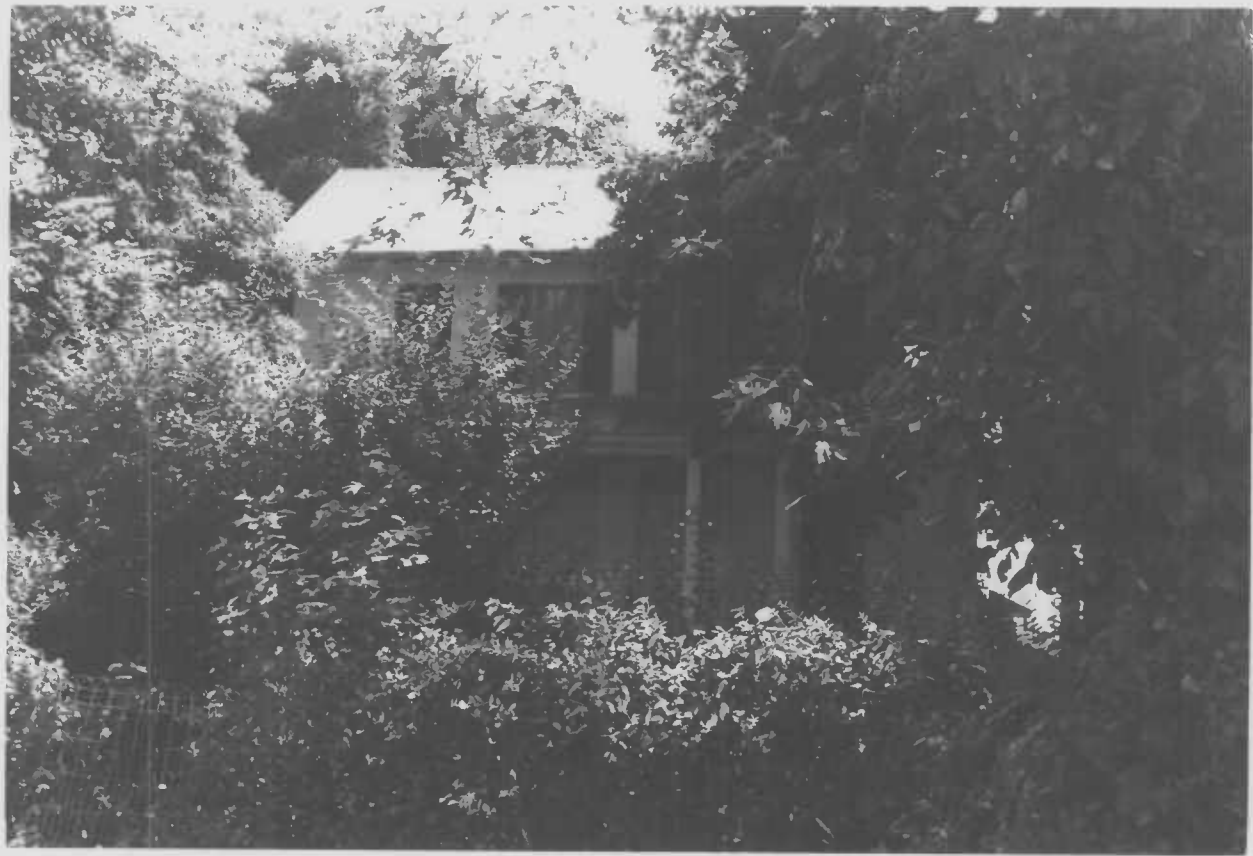
Two-story, four-bay by two-bay house with an L-shaped plan. Contains two entrances in the central two bays in a manner found throughout German-settled regions of Pennsylvania, Maryland and Virginia. Exterior woodwork dates from the mid-to-late nineteenth century. The house is a representative farmhouse from the mid-to-late nineteenth century. It is currently uninhabited.

1. CARR-664 Old Westminster Road
2. Carroll County, Maryland
3. Joe Getty
4. August 1983
5. Md. Historical Trust, Annapolis, Md.
6. West elevation; camera facing east
7. 1/1
